**Flood Control Project Maintenance
Levee Inspections****LMA District Cover Sheet****Spring 2011 Levee Inspection Results****Yolo County Planning Resources and Public Works**

Levee Inspection Report By Mile - Spring 2011

Waterway						Bank	Unit Miles	Inspection Start/End	Inspector	
Unit No. 01 Right Bank Cache Creek						Right	0.29	03/30/2011 03/30/2011	John Williamson	
LMR No.	Levee Mile		Category	Item	Location	Rating	Action/Comment	GPS Latitude/Longitude		Issue No. Photo
	Start	End						Start	End	
1	0.00	0.26	Earthen Levee	Vegetation	LS	M	Remove the wild growth other than native grasses from the levee slopes. Inspector Comments: This area now has been declared an habitat restoration area by the Cache Creek Conservancy.	38.722123 ° -121.806923 °	38.725852 ° -121.806485 °	1 Y
2	0.01	0.26	Earthen Levee	Vegetation	WS	M	Remove the wild growth other than native grasses from the levee slopes.	38.722420 ° -121.806997 °	38.725887 ° -121.806550 °	17 Y
3	0.02	0.25	Earthen Levee	Crown Surface / Depressions / Rutting	CR	M	Keep the crown roadway free of vegetation.	38.722450 ° -121.807001 °	38.725754 ° -121.806515 °	2 Y
4	0.03	0.03	Earthen Levee	Vegetation	WS	W	Elderberries are blocking visi

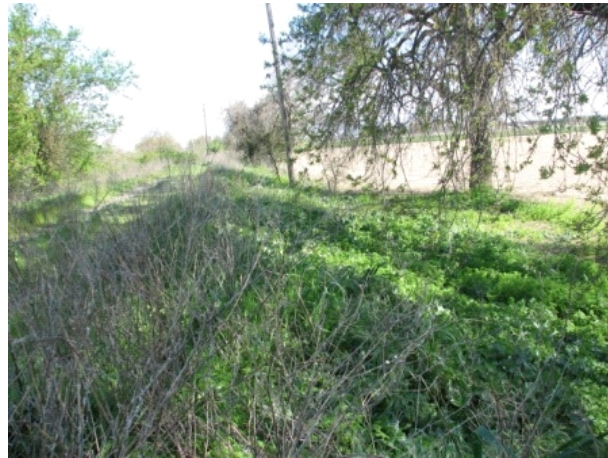
johngw_s_20110404_418.jpg

Levee Mile Report Line	1
Start Levee Mile	0.00
End Levee Mile	0.26
Location	Land Side
Category	Earthen Levee
Item	Vegetation

The landside vegetation does not meet standards.

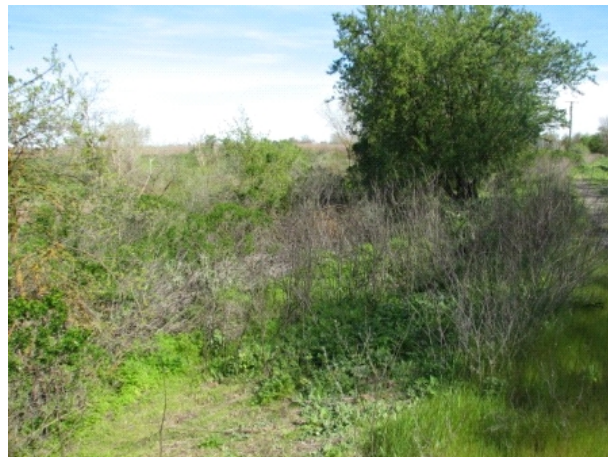
johngw_s_20110404_419.jpg

Levee Mile Report Line	2
Start Levee Mile	0.01
End Levee Mile	0.26
Location	Water Side
Category	Earthen Levee
Item	Vegetation

The waterside vegetation needs to be thinned and trimmed.

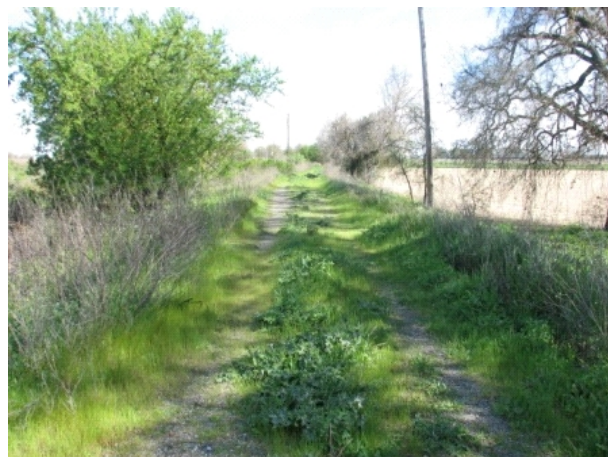
johngw_s_20110404_417.jpg

Levee Mile Report Line	3
Start Levee Mile	0.02
End Levee Mile	0.25
Location	Crown
Category	Earthen Levee
Item	Crown Surface / Depressions / Rutting

The vegetation on the crown does not meet standards.

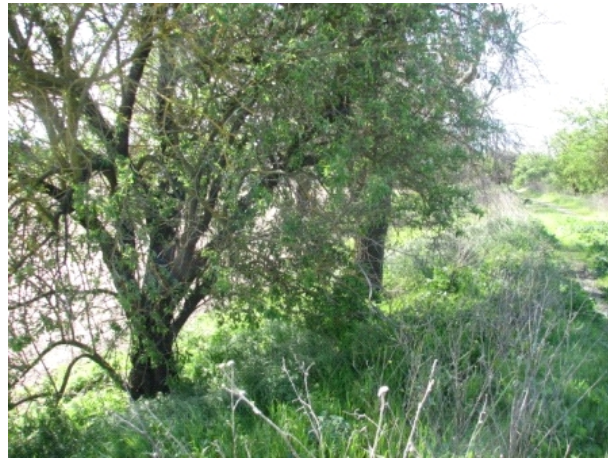
johngw_s_20110404_420.jpg

Levee Mile Report Line	5
Start Levee Mile	0.03
End Levee Mile	0.06
Location	Land Side
Category	Earthen Levee
Item	Trim / Thin Trees

The trees need to be thinned and trimmed up for visibility.

5	0.03	0.06	Earthen Levee	Trim / Thin Trees	LS	M	Trim and thin trees to allow visibility of the ground and room to flood fight.	38.722699 ° -121.806920 °	38.723001 ° -121.806864 °	19 Y
6	0.08	0.08	Earthen Levee	Trim / Thin Trees	LS	M	Trim trees to at least five feet above ground level.	38.723375 ° -121.806762 °	38.723375 ° -121.806762 °	20 Y
7	0.13	0.13	Earthen Levee	Trim / Thin Trees	LS	M	Trim trees to at least five feet above ground level.	38.723903 ° -121.806613 °	38.723903 ° -121.806613 °	6
8	0.15	0.15	Earthen Levee	Trim / Thin Trees	LS	M	Trim trees to at least five feet above ground level.	38.724165 ° -121.806552 °	38.724165 ° -121.806552 °	7 Y
9	0.17	0.17	Earthen Levee	Trim / Thin Trees	LS	M	Trim trees to at least five feet above ground level.	38.724445 ° -121.806505 °	38.724445 ° -121.806505 °	8
10	0.21	0.21	Earthen Levee	Trim / Thin Trees	LS	M	Trim trees to at least five feet above ground level.	38.725022 ° -121.806478 °	38.725022 ° -121.806478 °	9

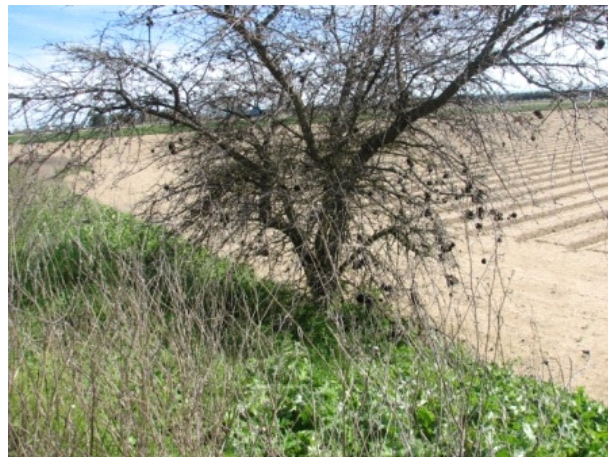
johngw_s_20110404_421.jpg

Levee Mile Report Line	6
Start Levee Mile	0.08
End Levee Mile	0.08
Location	Land Side
Category	Earthen Levee
Item	Trim / Thin Trees

The landside tree need to be raised up to meet the standards.

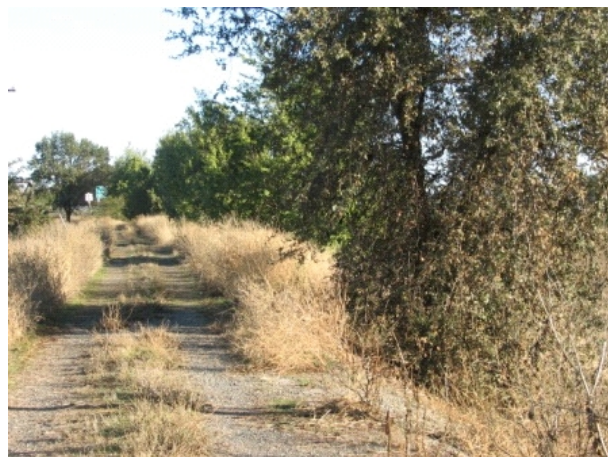
johngw_s_20110228_140.jpg

Levee Mile Report Line	8
Start Levee Mile	0.15
End Levee Mile	0.15
Location	Land Side
Category	Earthen Levee
Item	Trim / Thin Trees

All trees on the landside need to be raised. This view is looking downstream.
